Experimental studies on fillet weldment joints by artisans in Ghana's Western Region

Abstract

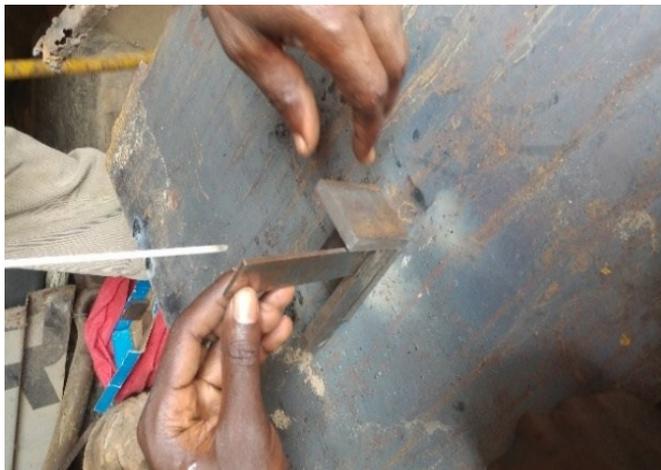
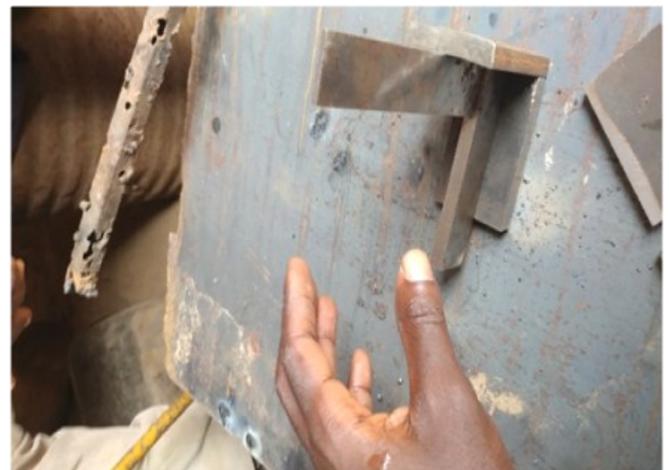
Figure 2 The (a) preparation process before welding, and (b) sample aligned for welding

Figure 1 shows the graphical illustration of the welded sample joint specimen and figure 2 shows how the sample materials

were taken to welding artisans for welding. The Corner-joint welding process MMAW was chosen for the weldment. For the Arc welding process, the artisans used two different types of electrodes. AWS E4310 defines carbon steel electrodes/low alloy steel electrodes. 2.5 mm/3.2 mm/4.0 mm/5.0 mm diameter, 300 mm, 350 mm, 400 mm length, titanium electrode coating, welding current 80-90 a, voltage DC+. ii. AWS E6013 - Electrodes made of carbon steel or low alloy steel. 2.5 mm/3.2 mm/4.0 mm/5.0 mm diameter, 300 mm, 350 mm, 400 mm length, welding current: 50-90A, voltage: AC 50V, DC+. The current and voltage of the machines were set based on the material and electrode. The sample materials were held on a welding plate, and the arc welding process was successfully completed at all shops visited, with an engineering square used to check for correct edges.

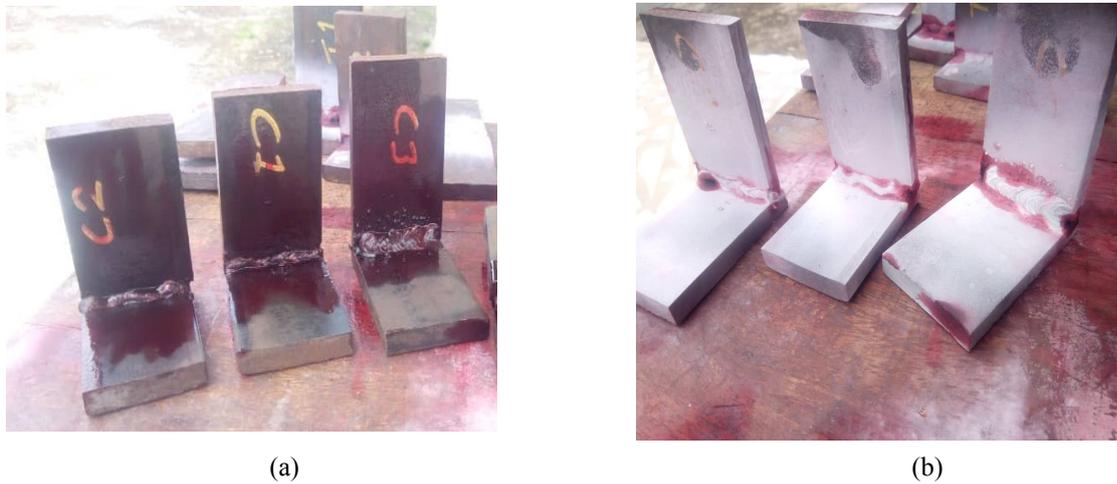
Figure 5 Sample with (a) dye penetrant applied and (b) results after developer applied

Table 4 and Figure 5 describes the results obtained from the dye penetrant test conducted on three corner joints. C1, C2,

and C3 which represents the codes given to the various specimen. The test results in table 4 shows clearly that all the results obtained indicate a rejection of the weldment joints defects which were lack of fusion, undercuts, and under fill per the code for acceptance. There is a clear indication that the corner weldment joint analysis with the dye penetrant test and assessed with the AWS D1.1/D1.M 2010 clause 6 of structural steel code of acceptance does not meet the standard of welding processes

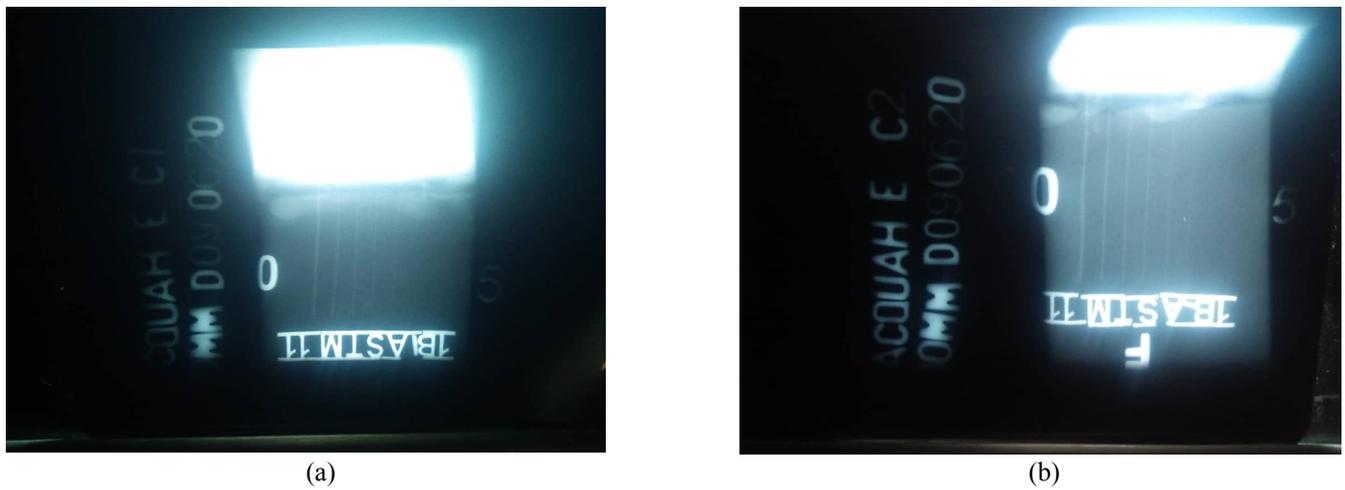
Figure 7 Radiographic inspection results of (a) sample C1 and (b) sample test results for C2

Table 6 and Figure 7 show the results for three specimens of corner joints tested with radiography inspection, the three specimens C1, C2, and C3 all recorded flaws such as lack of fusion, undercuts, and slag inclusions at specified distances measured from a reference on the weldment. After careful examination of the defects and compared with the acceptance criteria of AWS code for structural steels, all the welded specimen was rejected based on the acceptance criteria.
